INSTRUCTIONS TO FIT THE DRIVESHAFT BOOT

Half-shaft – To dismantle

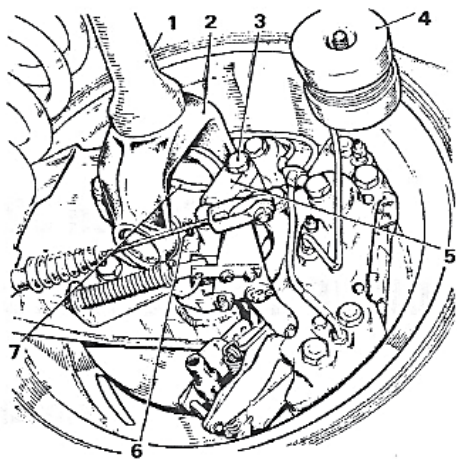
- 1 Half-shaft outer end
- 2 Hardy Spicer universal assembly
- 3 Bearing cap retaining setscrew
- 4 Harmonic damper
- 5 Bearing Cap
- 6 Grease nipple
- 7 Retaning strap, Hardy Spicer races
