Fitting instruction for modified rear hub seal (UR70222) and retainer (UR70221)

Rear hub seal

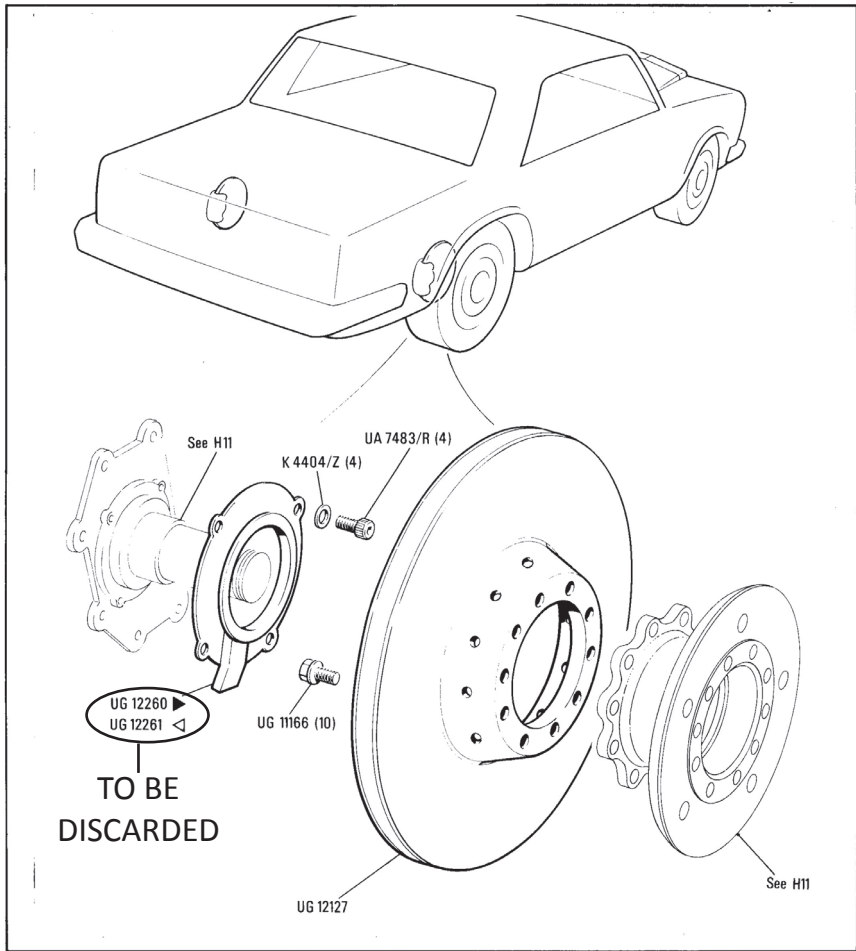
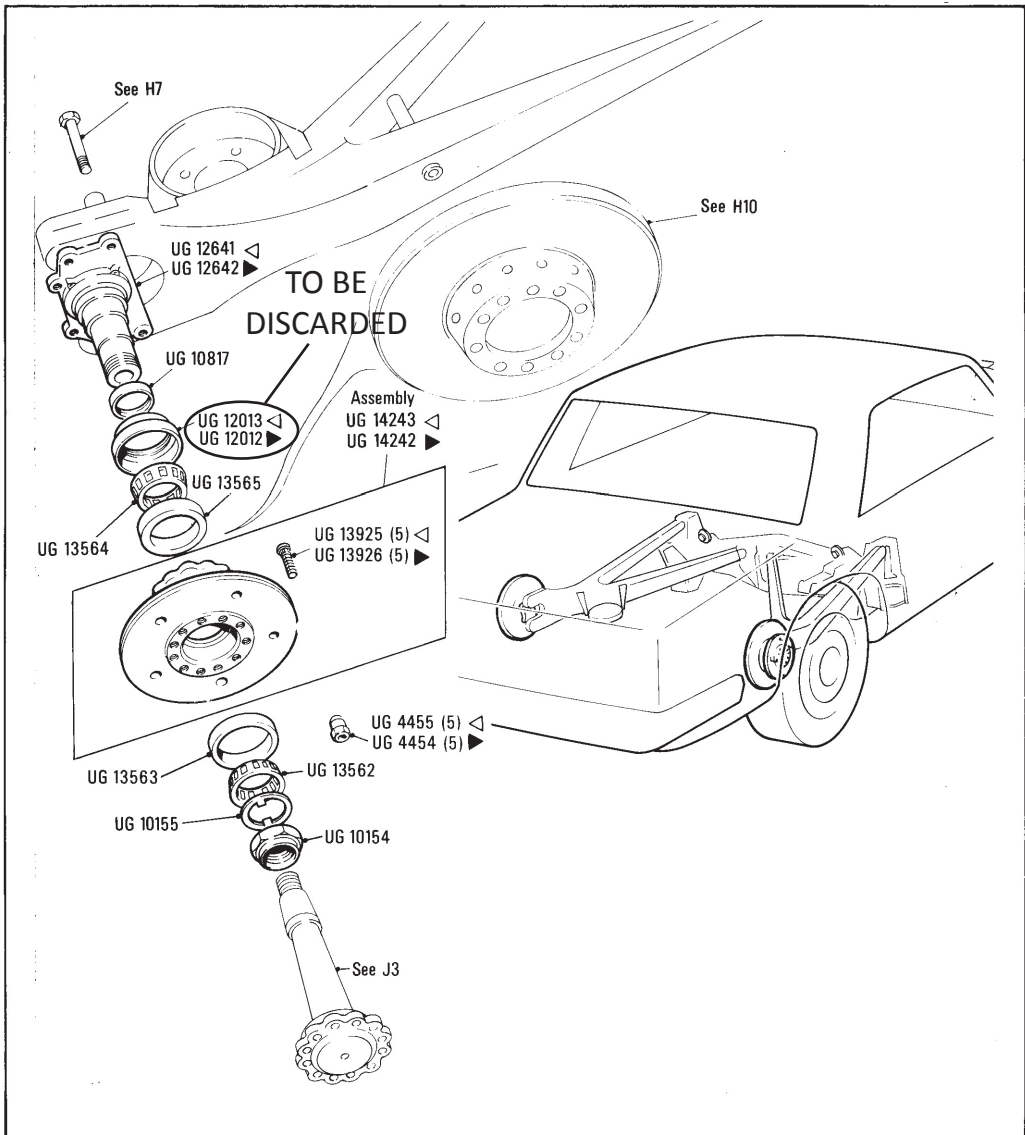
A PTFE lip seal which offers improved grease retention is fitted to the above motor cars. The seal is now supplied for all motor cars listed under the heading Applicable to.

- Remove the hub assembly from the motor car.
- Dismantle the hub assembly sufficiently to enable the grease retainer and disc shield to be removed and discarded.
- Wash out and dry the hub and bearings. Check the condition of the bearings and if serviceable, repack with recommended grease.
- With the inner bearing in position, press in the seal retainer with the counterbore uppermost until it contacts the bearing.
- Carefully remove the seal from the mandrel and with the lip facing the hub, press the seal into the counterbore in the retainer.
 Ensure that the seal does not contact any oil or grease. The seal must be fitted dry.
- Degrease and clean the shaft diameter on which the seal will run. Do not lubricate the seal or shaft.
- Re-build the hub.
- Re-fit to the motor car.
